# United Kingdom South Wales

*Case Study*

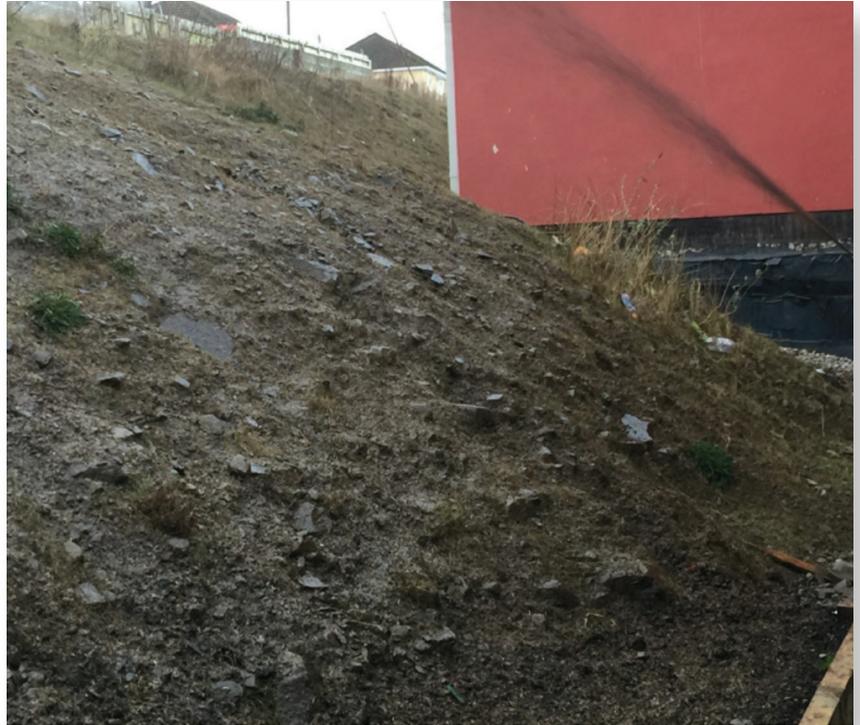
*Biotic Earth applied over existing conditions where previous seeding operations failed.*

When the building and site work was completed the landscape required seeding to stabilize the soils and complete the desired environment. After construction there was very little topsoil and what was available was nutrient deficient and made vegetation establishment on the steep shaded slopes difficult. After an initial, traditional, hydroseeding application had failed the foot traffic on the slopes used as a short cut to access the building began to cause increased erosion on the site and result in significant long term maintenance costs.

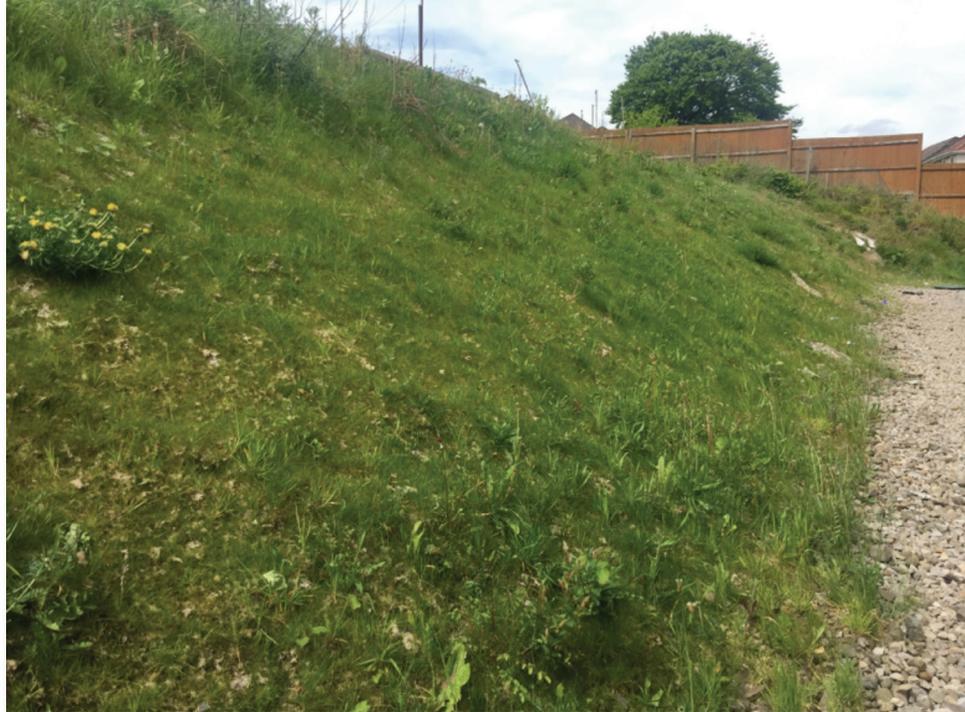
*Vegetation establishing and erosion has been successfully prevented.*

The solution was provided by Glyncoch Community Regeneration LTD, when the assistance of a new approach to revegetation was specified. With the poor soil conditions at the site combined with the steep slopes that would make importing and spreading topsoil cost prohibitive, Biotic Earth, a biotic soil amendment was applied with a mixture of tall and hard fescues and perennial ryegrass and slow release organic fertilizer. The second hydroseeding application to the shady slope area has been considered a great success. The revegetation was successful and the area has been left to grow wild and natural to encourage wildlife back into the area.
